Sunday, Feb 13, 2022

Wing wall fix

Lawn sprinklers soaking decorative wing walls caused wood rot. Pressure-treated lumber will fix.

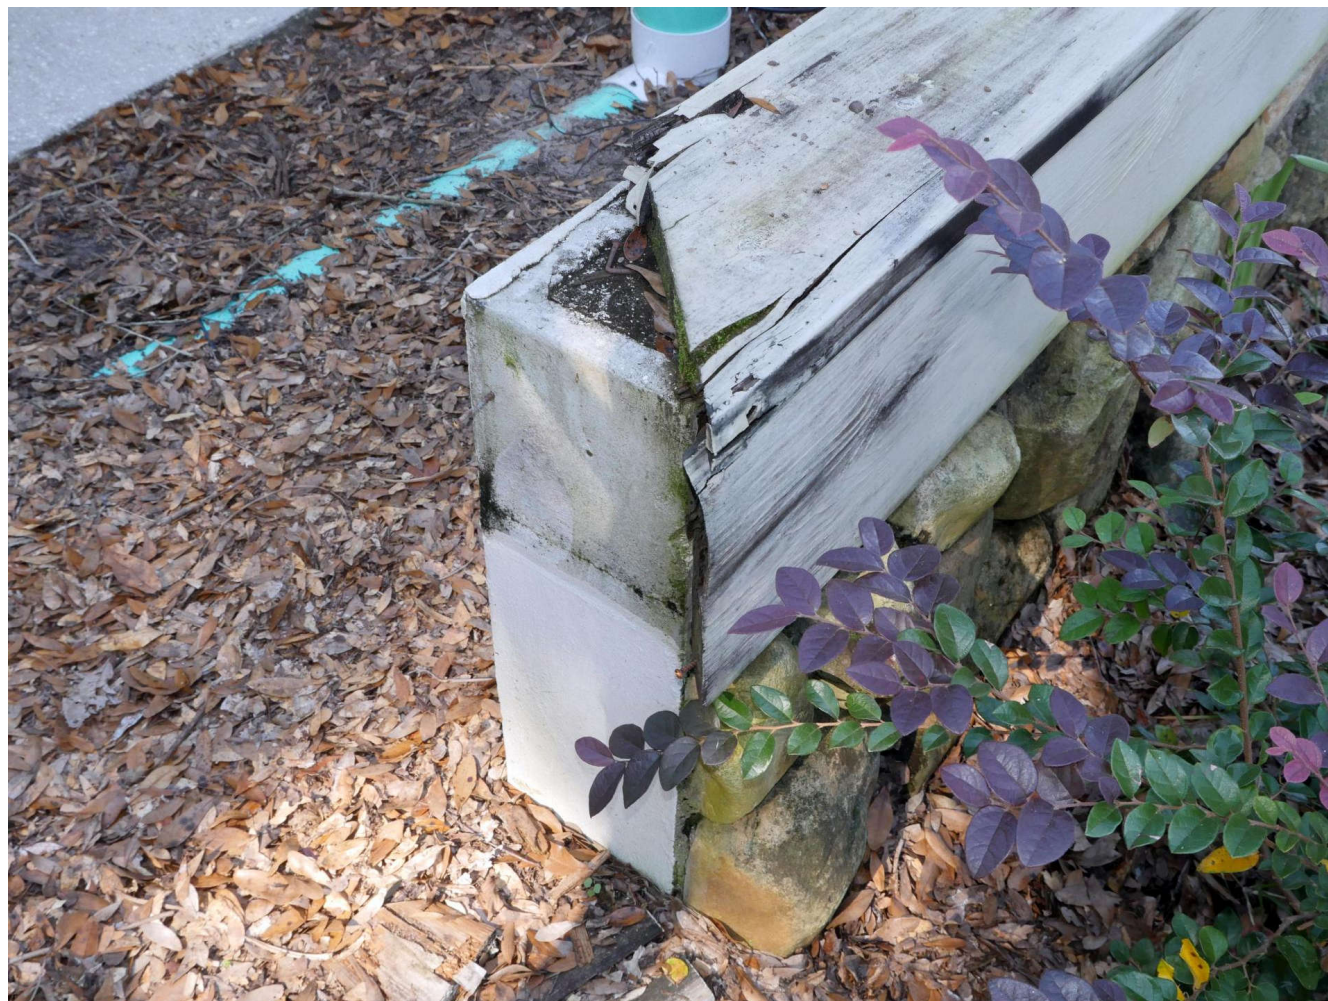
My house has three decorative wing walls in the front. The previous owner did not trim the bushes for 28 years. To allow the lawn sprinklers to spray over the bushes, a contractor raised the spray heads above the level of the wall. The walls would get sprinkled over-spray twice a week. This is in addition to the plentiful Florida rains. This end cap just fell off one day, very ugly.

The builder put a 45-degree cut at this end, so that there was a continuous surface to fit the end cap. I decided to eliminate this 45-degree cut and just have the top board go all the way to the end. This does leave a little empty triangle at the corner. A small plug and some wood filler will fix this. Meanwhile, there is one less cut in the top board, where all the wood rot seemed to have started.

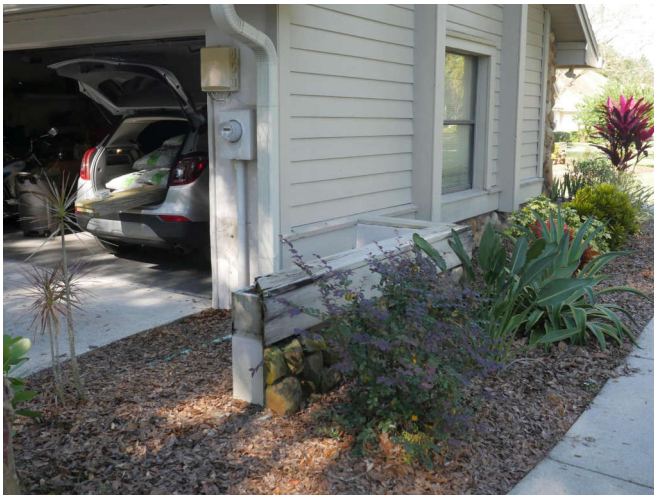
There are three decorative wing walls on the house. They are all suffering from wood rot.

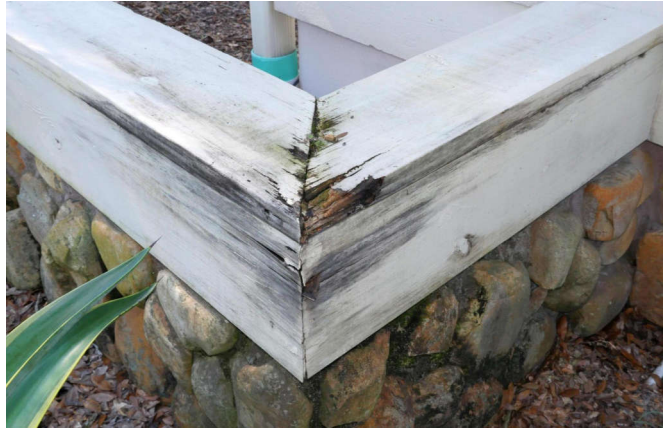
The corner of the wall had damage both from the top joint, and the vertical joint.

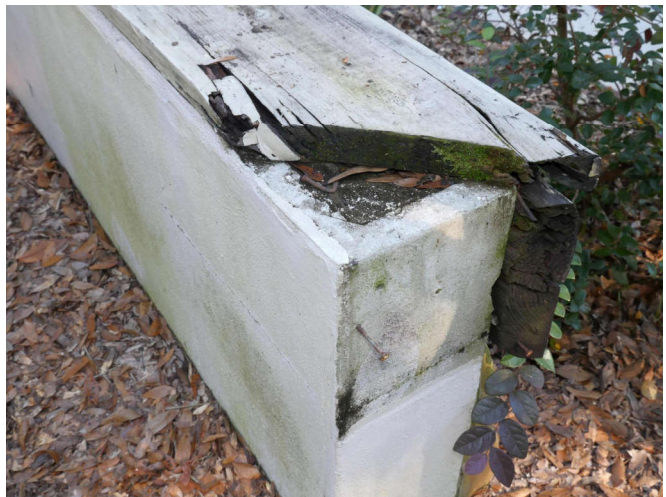
Here is a detail of the end of the wall. You can see putting in that 45-degree cut on the top allowed a continuous vertical scarf on the front edge of the lumber. A really complex cut on the top piece might eliminate the hollow spot that I ended up with, but I cared more about the top.

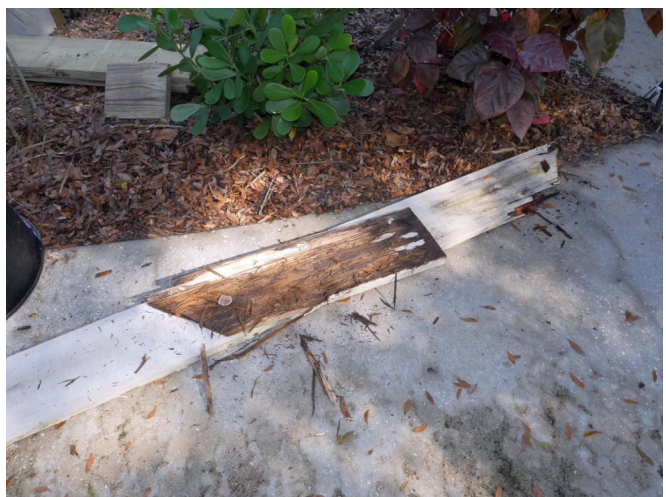
The short top piece is rotted at both ends. Using the pressure-treated wood solves this.

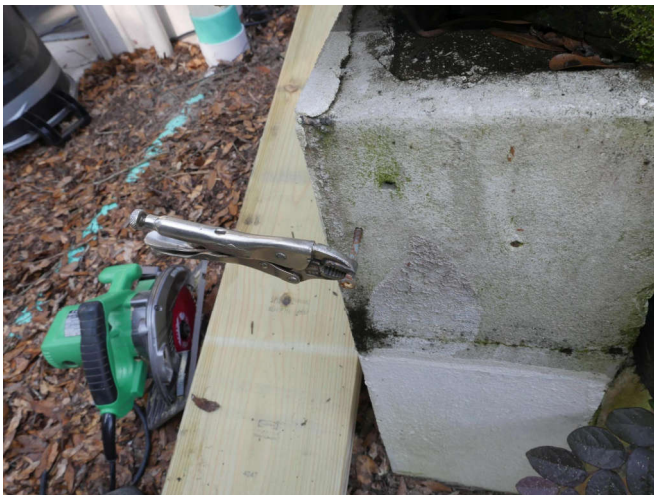
Most of the screws broke off. I used a right-angle grinder to grind them flush, as well as clean up the top surface of stucco excess.

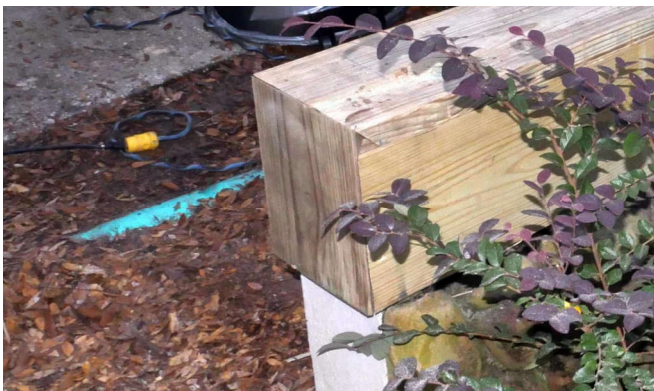
There is a little triangular hole in the corner. I prefer this to cutting a diagonal across the top where water can enter and rot the wood.

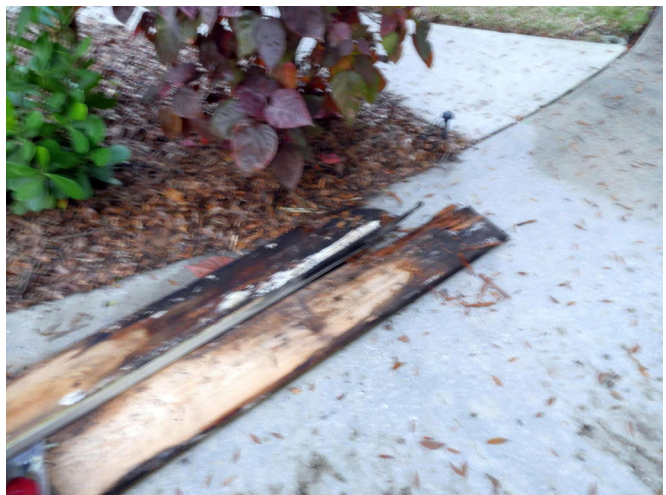
The old lumber was in very bad shape. Thankfully, it was not structural.
