Leave Cali day 29

I sell a set of Neway valve cutters and take a pictures of a broken sprocket cover for my 1962.

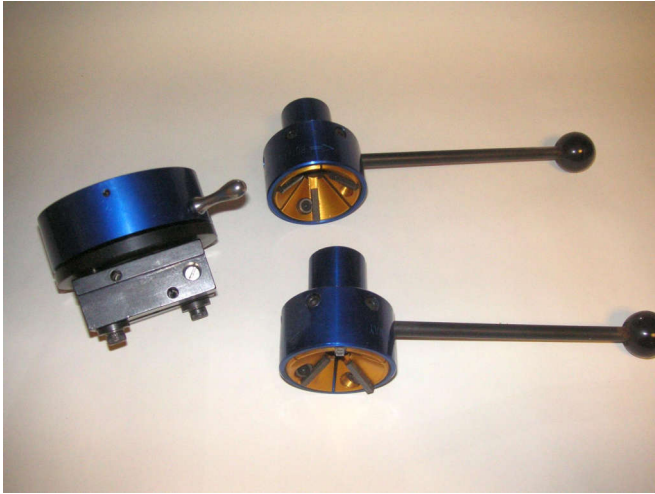
I had two different angle cutters. They fit into the unit at left, which clamps the valve stem.

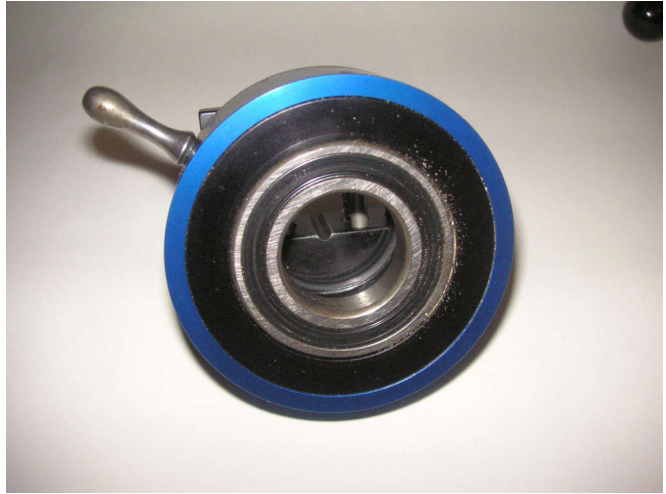
This is where the cutters fit. It has a precision bearing for the cutters to spin on.

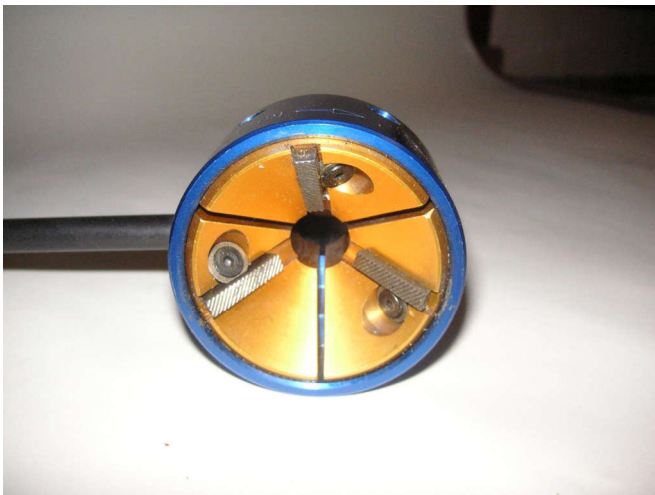
The view of the smaller Neway valve cutter.

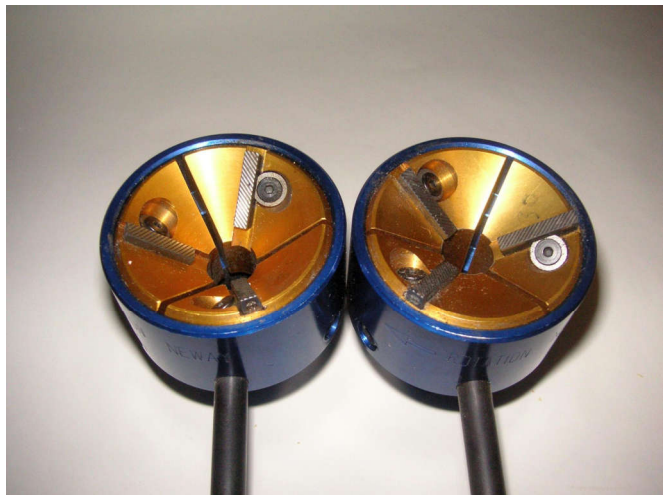
The two cutters side-by-side.

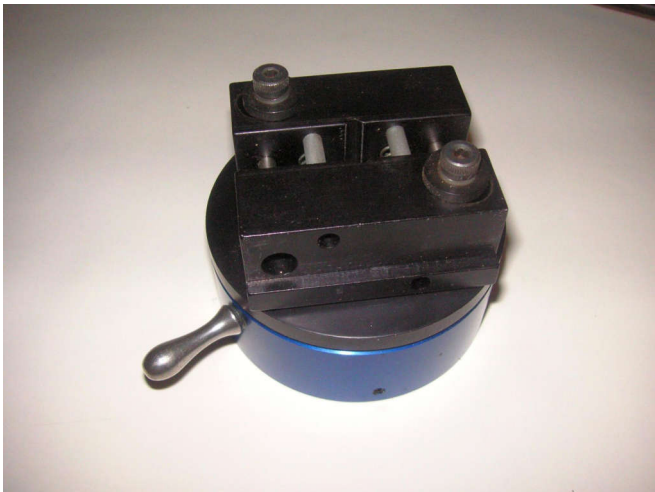
Here is the clamp mechanism for the valve stem. This sold fast on eBay, I can't remember what I got for it..

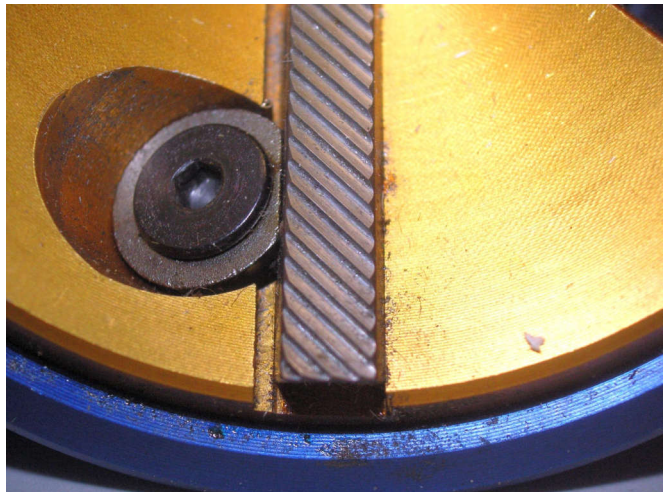
A close-up of the clamping method for the carbide blade. This is well-made stuff, and made in the USA as well.

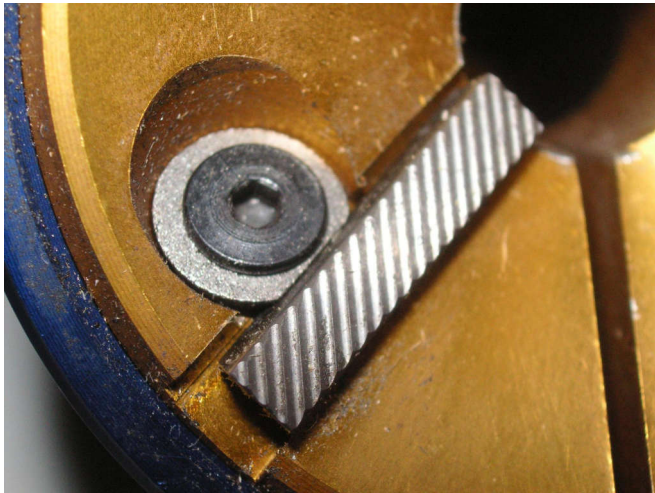
Here is the larger cutter. You can slide the carbide blades to give fresh cutting action.

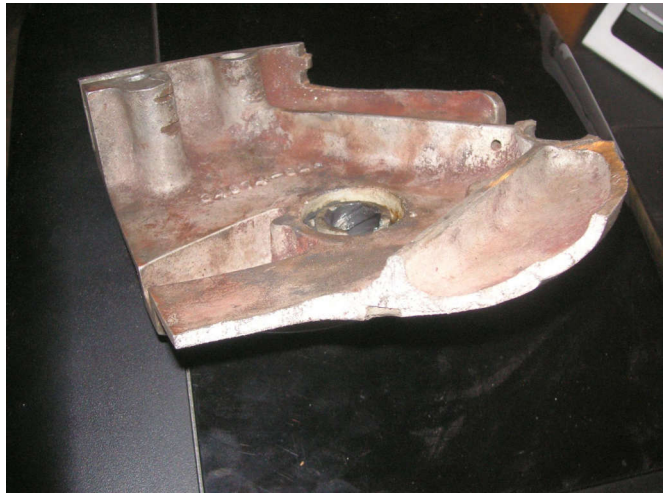
This was a real tragedy, it broke the cases of my 1962 Sportster right through the speedometer drive area in the transmission. Rather than taking the engine completely apart, I used JB Weld to put the case back together. It has held up, and does not leak, but I have not put many miles on the bike since then.

So for the 1962 Sportster, I used a conventional chain, but I had no chain oiler. Yes the chain did get saggy when it broke, but it was not a loose chain itself that broke the cases. What happened was the chain adjuster on the swing-arm right side broke where the stud attaches to the ring that the axle runs through.

So I was on the throttle leaving for work, and the adjuster broke, and the torque pulled the axle all the way forward. That put so much slop in the chain, it could double-up and jam in the sprocket cover, wrecking it and blowing a chunk out the engine case. One 3-dollar part.

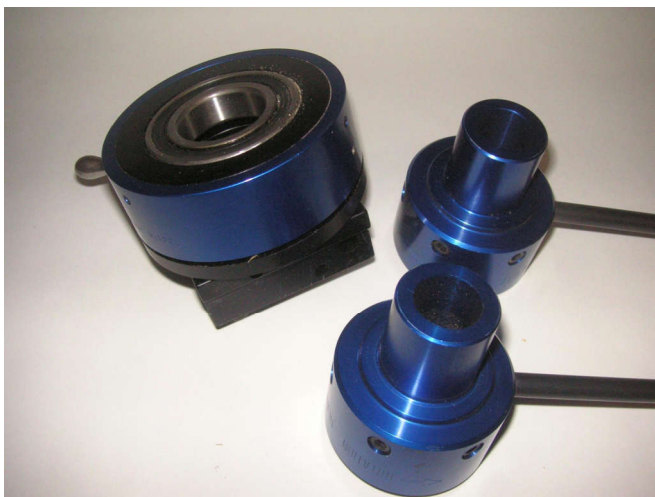
The back view of the cutters. They looked brand new when I bought them on eBay.

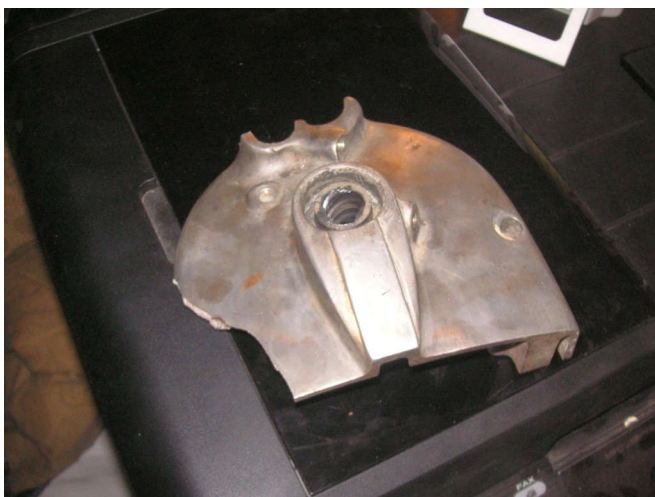
I thought the way I let this happen was letting chain get too loose. On my other 5 Sportsters, I use O-ring chains that I put on with a brand new transmission sprocket. They usually last a lifetime, since I divide my miles across all the bikes. For the 1962, the sprocket cover was too narrow, and an O-ring chain would grind chunks of aluminum out of it.

I wanted to toss out this broken sprocket cover from my 1962 Sportster, so I took a picture.
