Leave Cali day 35

I find out what broke in the transmission of my 1996 Sportster. A 20-cent clip split in two.

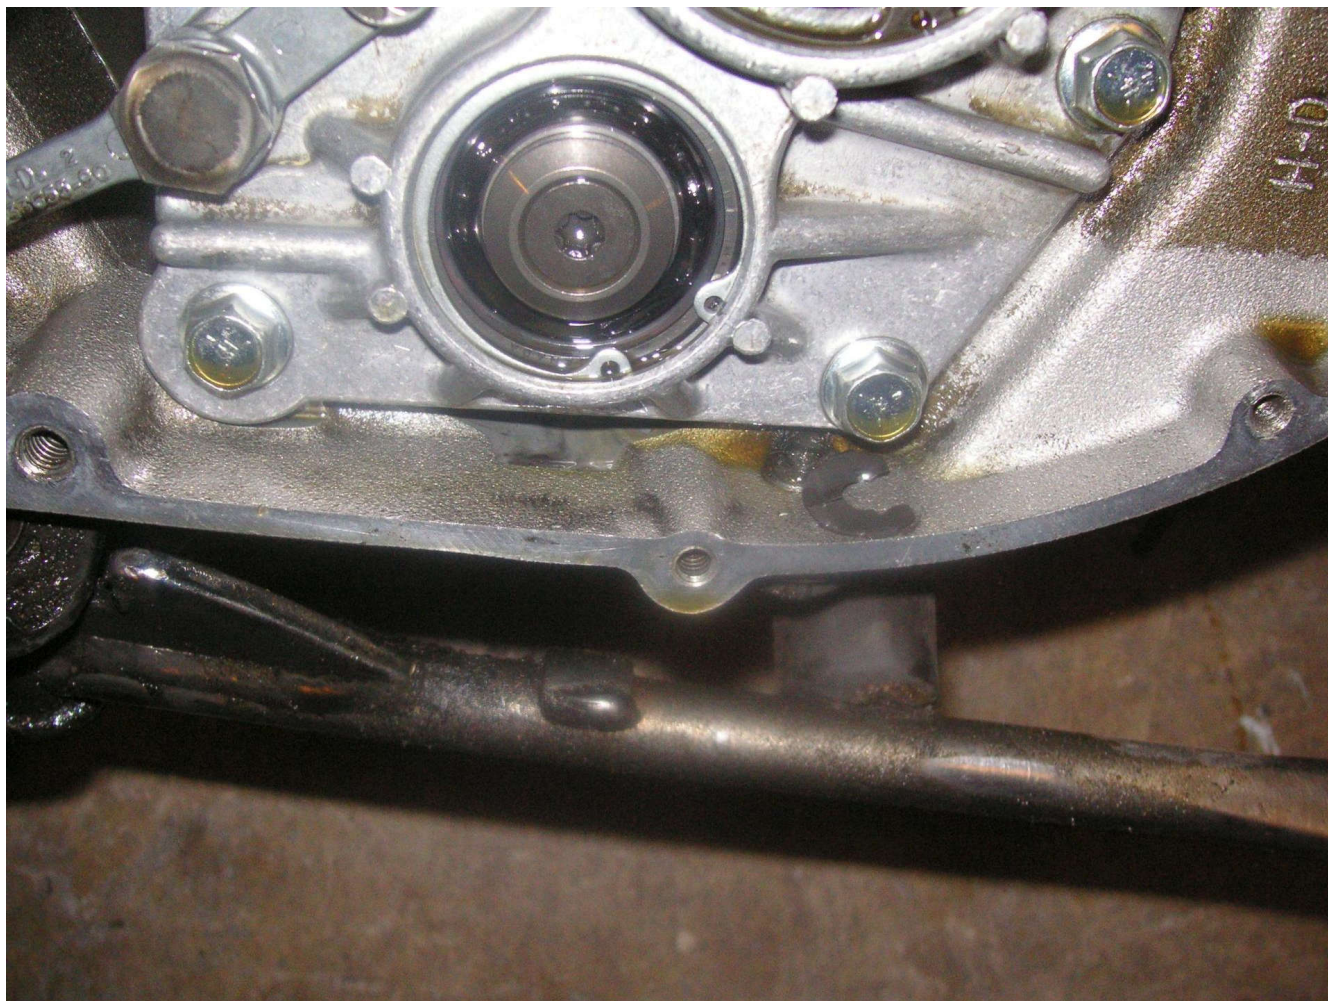
The picture above shows the little broken clip that came off the shift drum. This might have started when I dropped the bike at 60 mph a few months earlier. The guy in front of me missed the bush that fell of the gardeners trailer. I didn't. Broke a finger and cracked my elbow, but minimal damage. I healed up, the bike decided to break on the way to work. No shifter, I limped seven miles home in one gear.

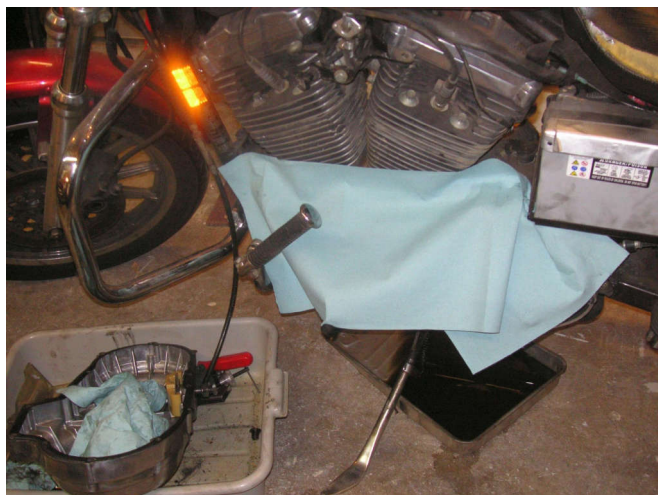
I usually would wash everything, this was a quick job, I just covered the tranny up.

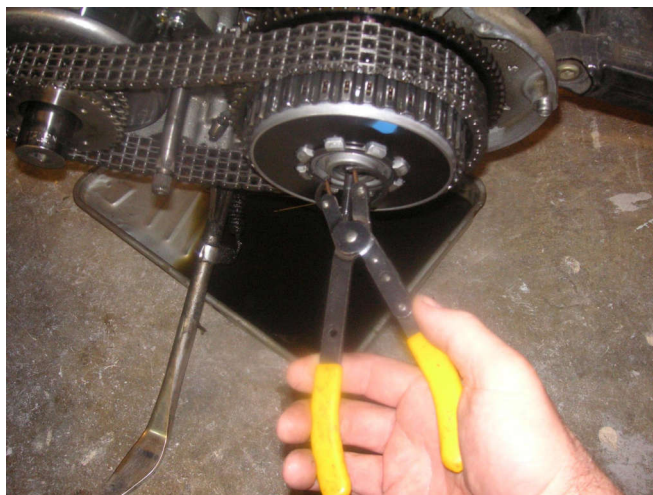
I remove a snap ring from the clutch basket. I wished the shift drum used one as good.

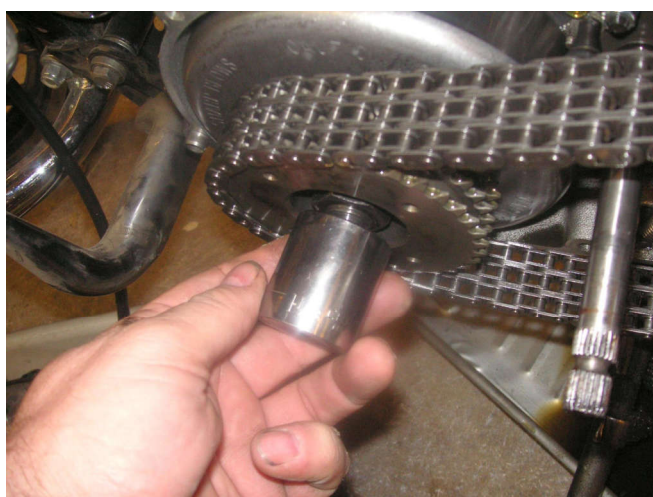
The inch-1/8 shallow socket did not clear the sprocket shaft.

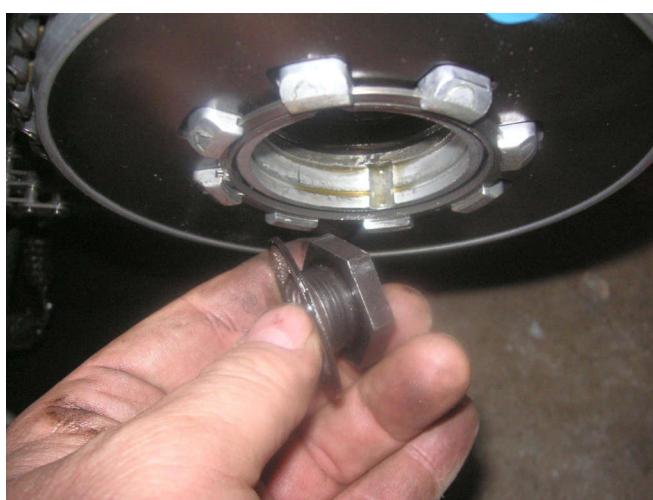
This adjuster nut comes out of the clutch basket.

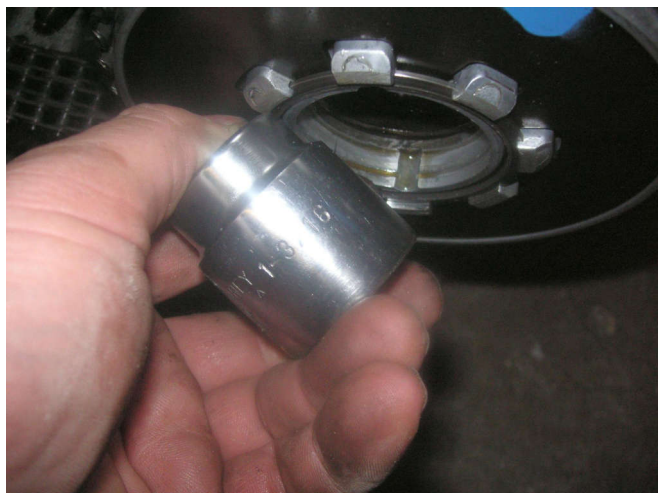
It's an inch-3/16 socket to get the clutch basket off.

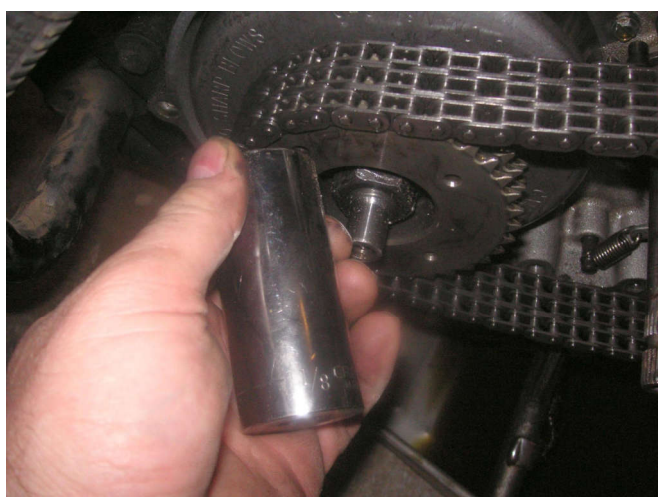
The deep-well 1-1/8 socket gets past the sprocket shaft and pulls the nut up front.

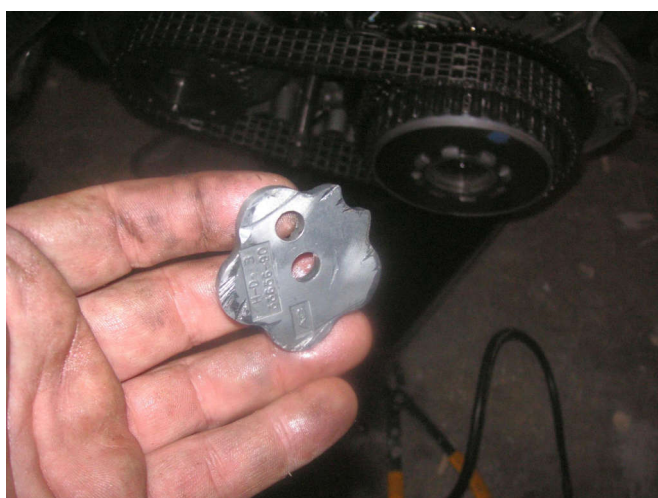
This is the detent drum that holds the bike in any given gear. It fell off with the clip.

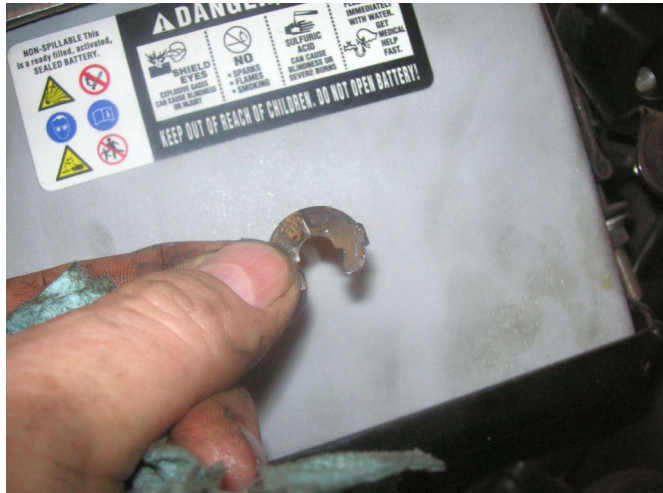
This is the 20-cent clip that broke off. Though as a Harley part, it probably was three bucks.

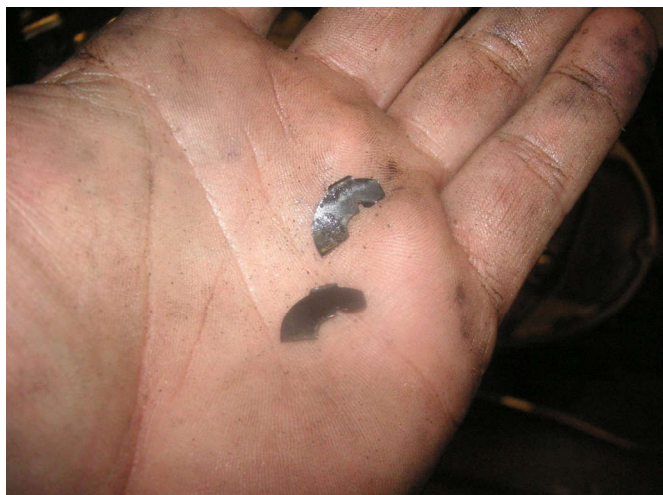
Just touching it and it broke into two.

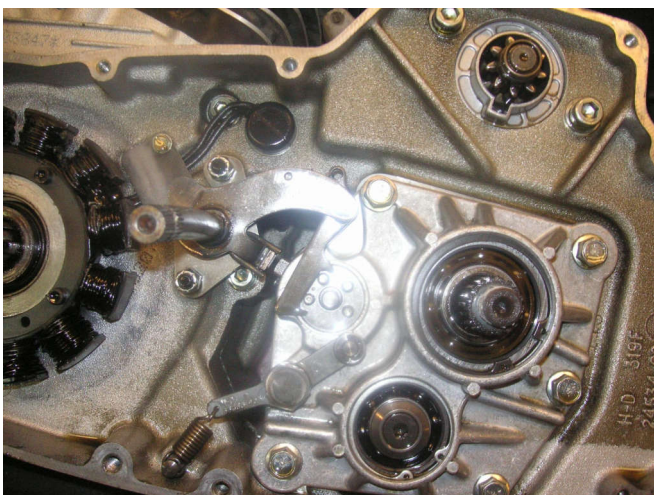
I shine a light where the shifter drum had that clip and detent wheel come off.

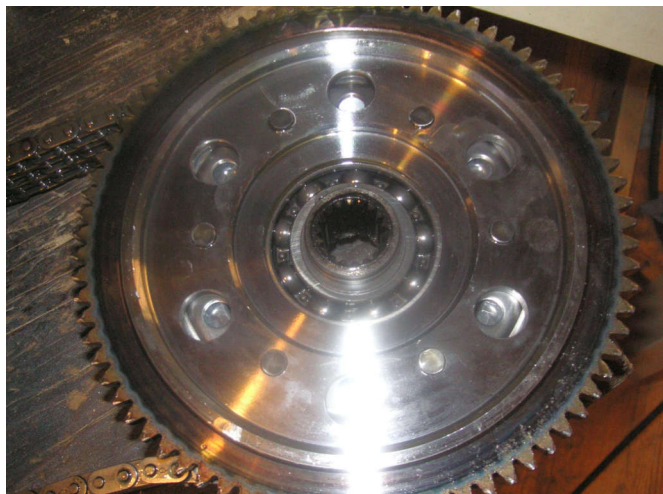
I was worried the loose detent drum had torn up the back of the clutch basket. Lucky me, the clutch basket was OK, no collateral damage.

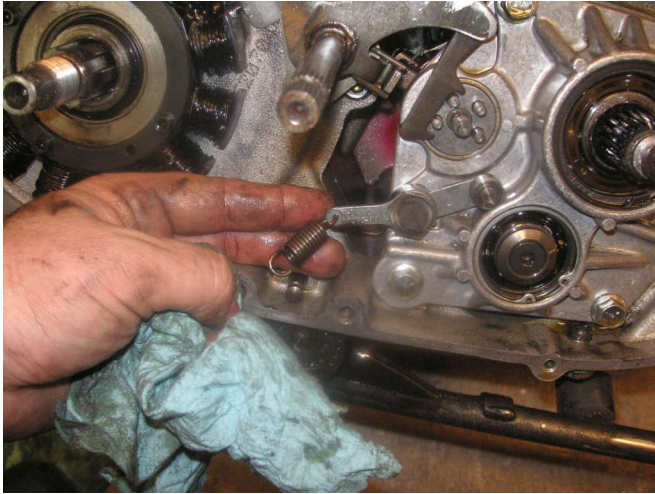
When the clip and drum popped off the shift drum, the spring came off the case mount.

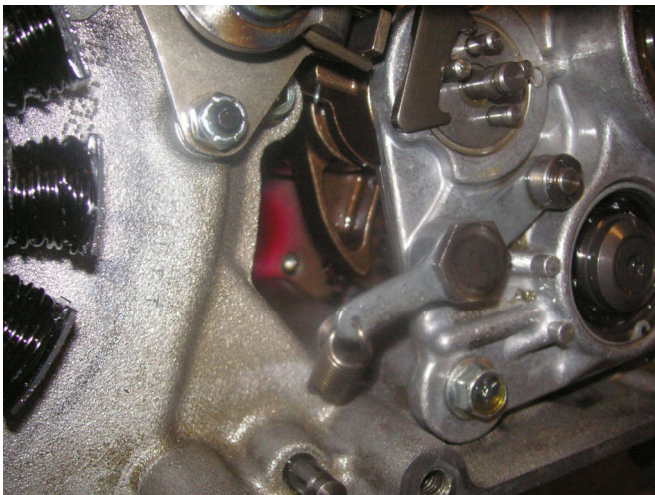
The inside of the tranny looked OK. No need to pull the trap door.

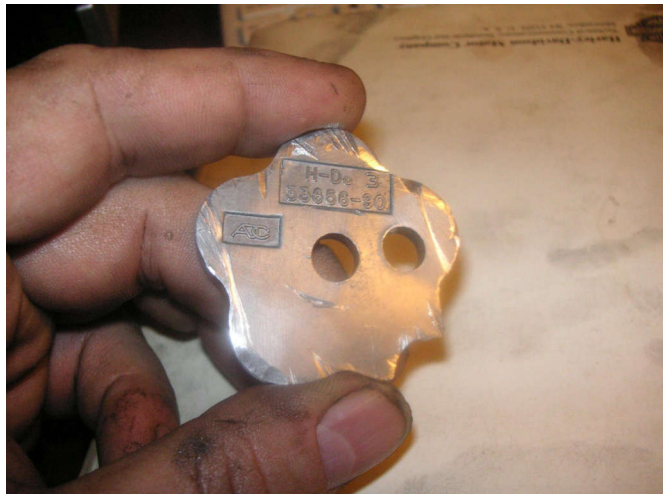
Here is the shifter detent drum, a little torn up from rubbing on the back of the clutch basket. Tomorrow I put it back together.
