1992 Honda tail light gasket

My 1982 Honda tail light gaskets leaked. My 1992 Honda tail light gaskets leaked. Fix this gents.

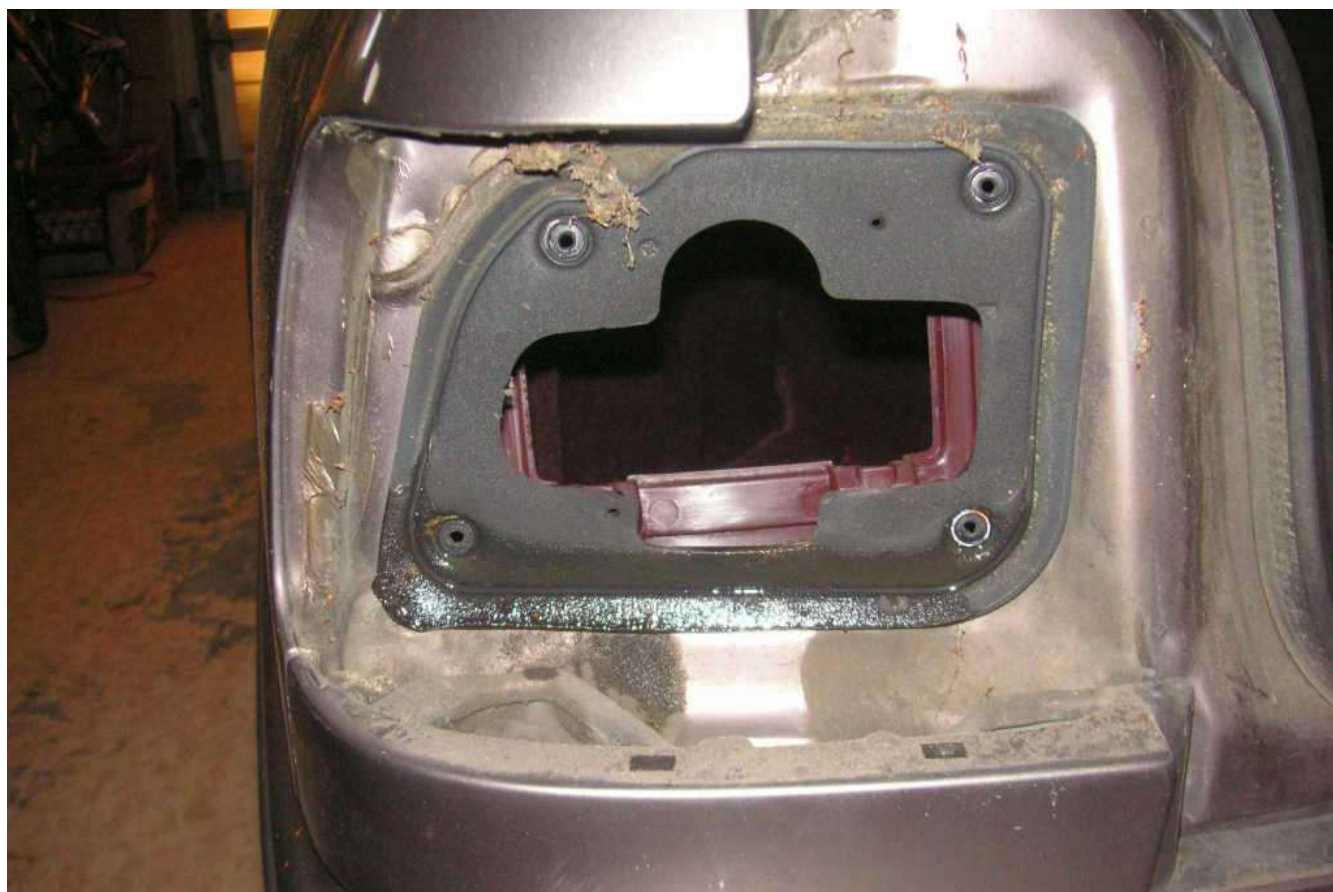
There must be some old stubborn engineer at Honda that insists of this half-assed design. The gaskets on my 1982 Honda leaked. Note how the water draining the trunk goes right on top the lamps. I noticed the car would fog up on the inside when it was cold. When I lifted the spare tire cover, the trunk had standing water in it. As you would expect from something older, the gasket replacement was more straightforward since engineers were more in control that sales weenies.

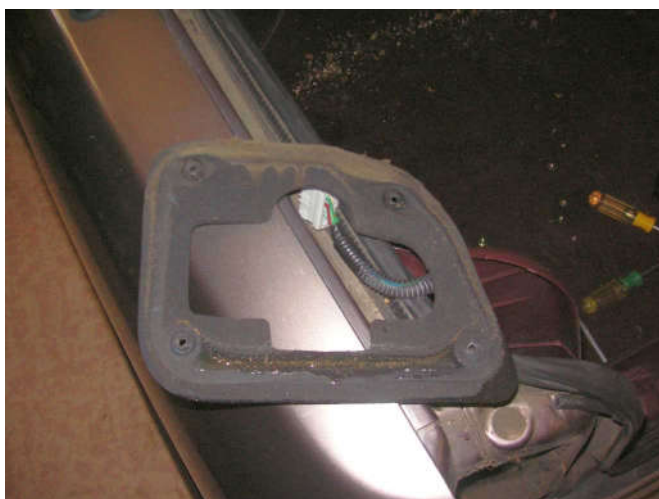
The front of the gasket show the drips.

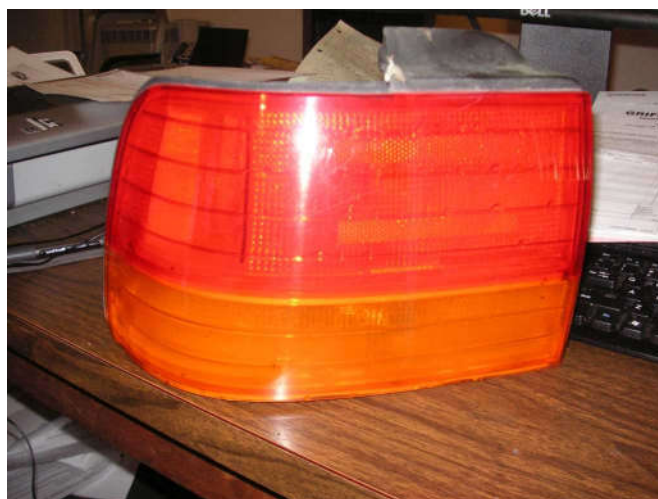
You can see about a half-inch of water inside the tail light, behind the orange plastic.

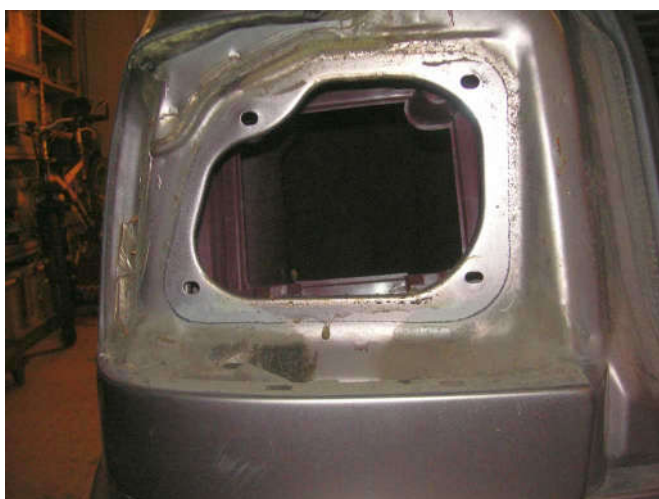
Thankfully, no rust on the body. It will clean up OK, and I hope the new gasket seals.

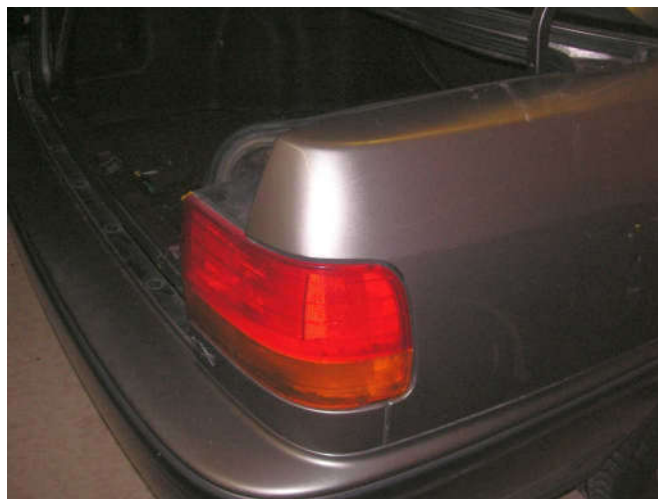
The right tail light has water and mold.

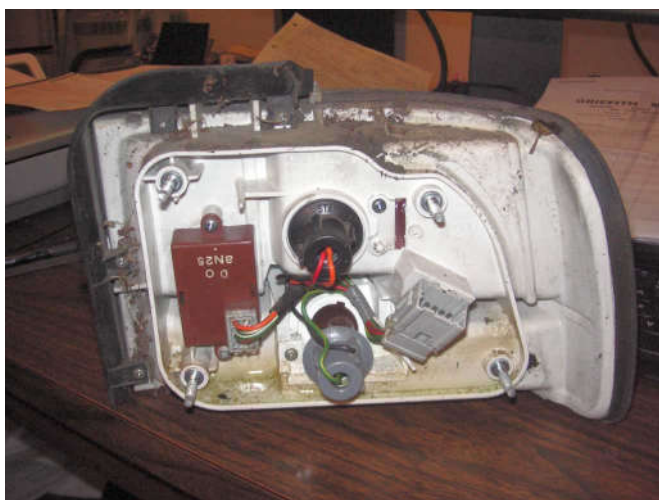
Here is the backside of the right tail light. The lip pressed against the gasket and seemed to seal OK on this side.

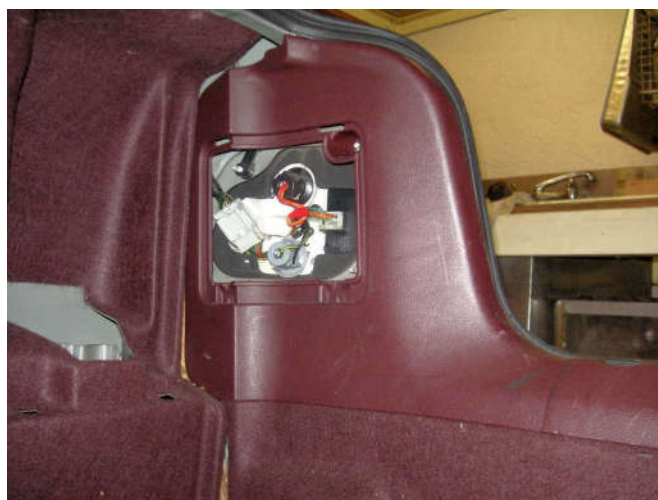
Popping off this inside cover provides access the bulbs but not all the screws.

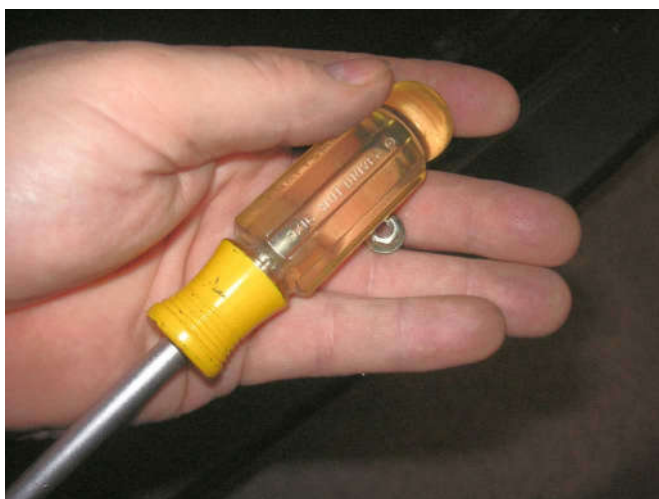
A 5/16 nut driver gets the job done.

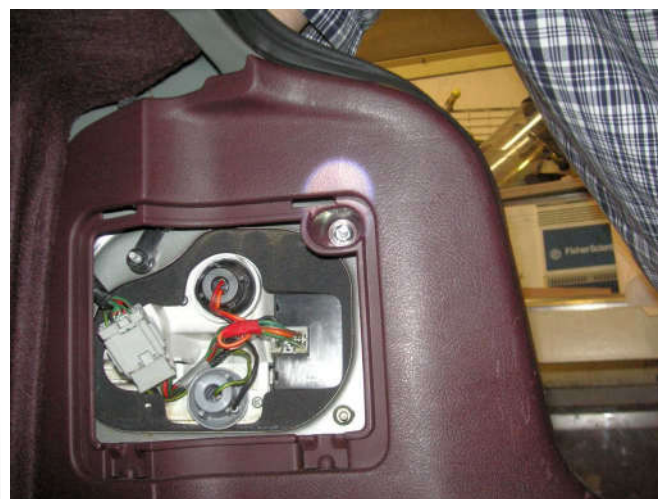
They tease you by providing access to only three nuts.

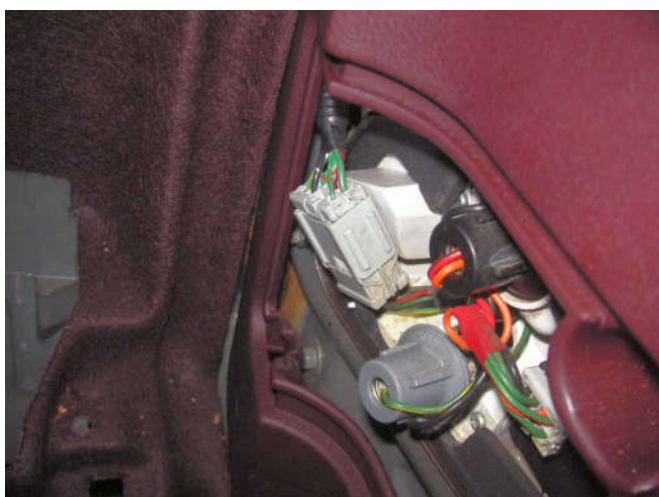
The harness connector clips to the body.

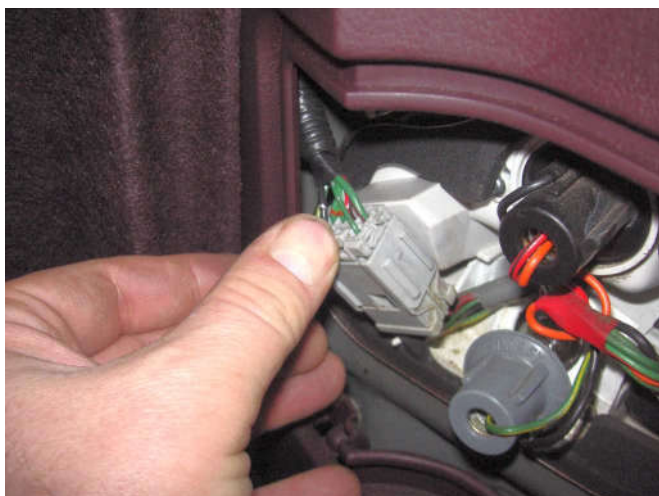
Satanic engineers dreamed up this release method. Press in on this little nub and it allows you to separate the connector.

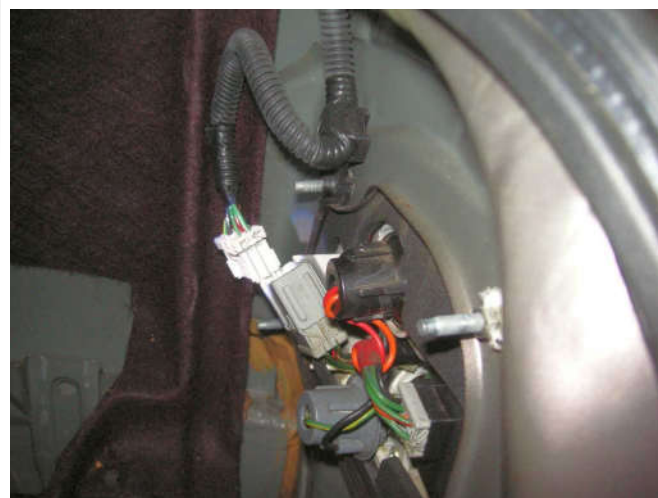
Now you have access to all 4 nuts holding the tail lamp housing.

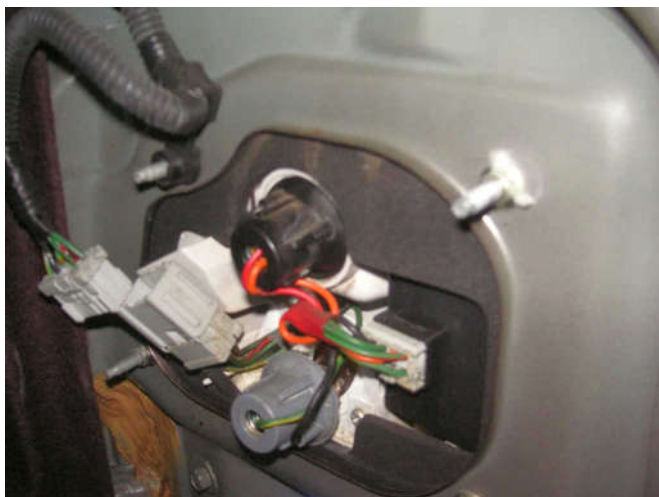
Connector off, you can leave the bulbs in.

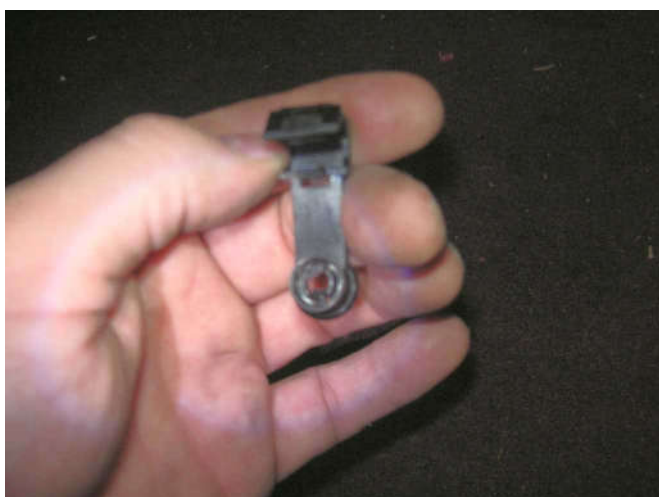
The wire harness clip has its own Satanic release be sure to put it back in.

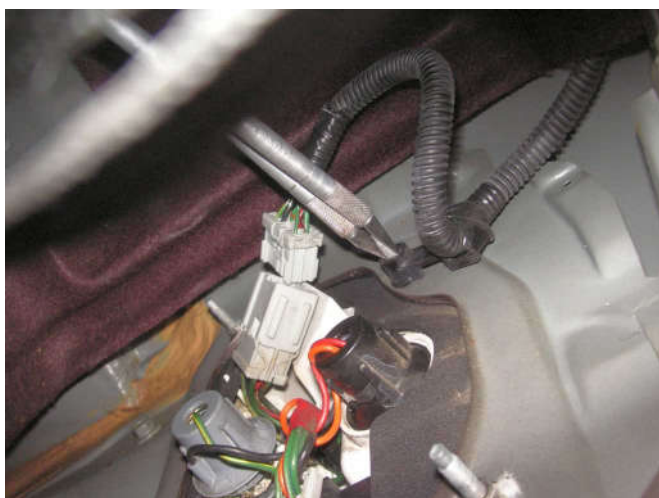
Here I use two X-acto knives to try and release the little tabs pressing against the stud. This is one of the little evils-- one-way clips.

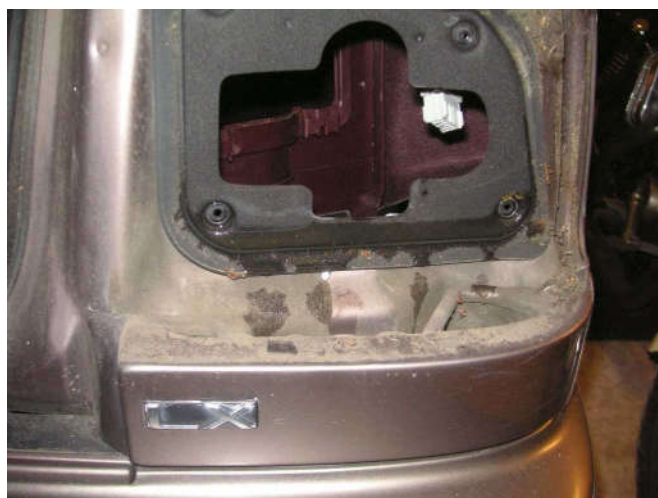
Water collected on the bottom but the leak is at the top on the other side of the gasket.

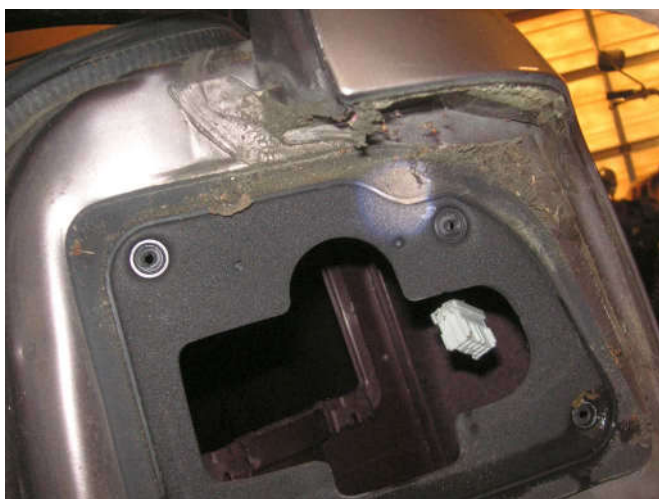
The lip on the lamp seems to have sealed OK.

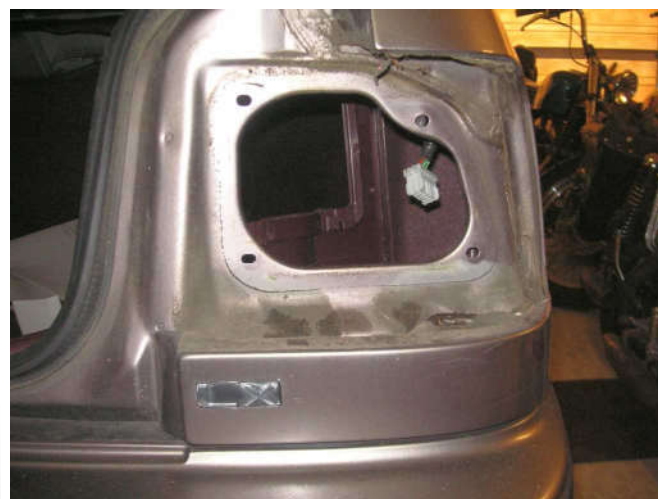
Right side has no rust, a good sealing surface.

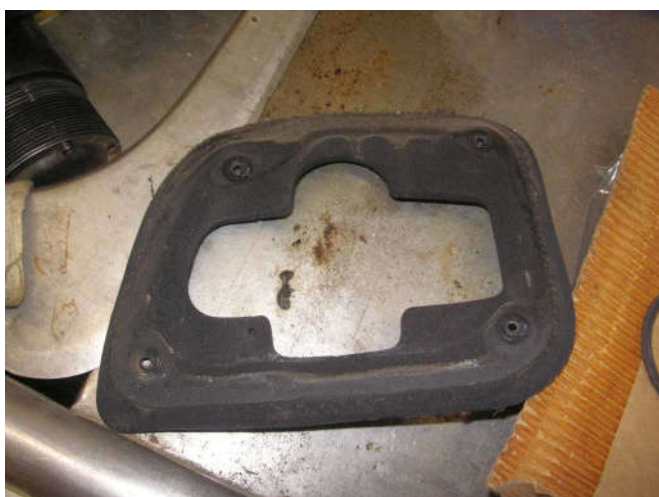
Front side, where the leak was at the top.

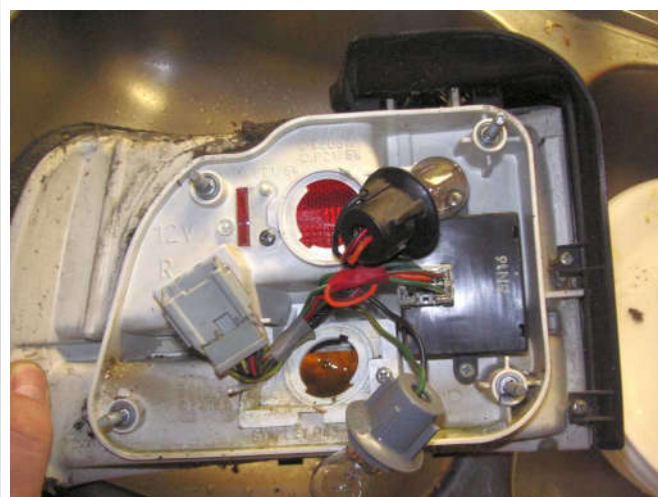
Backside of the right lamp, bulbs pulled.

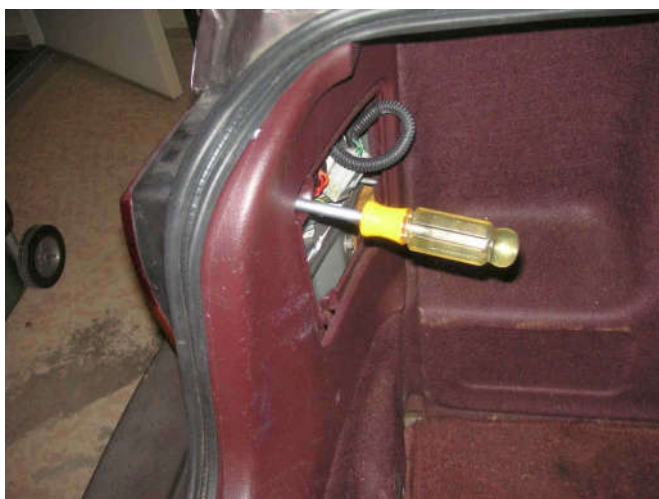
That fifth nut holds in the interior plastic.

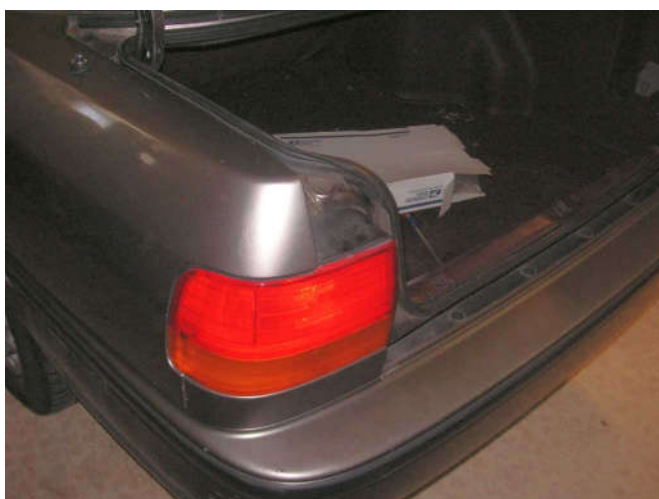
finished job, no water in the lamp.

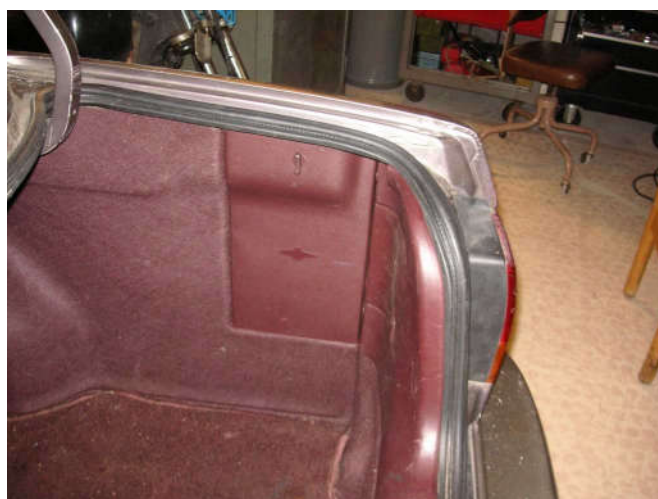
The jock cover goes back in with a twist.

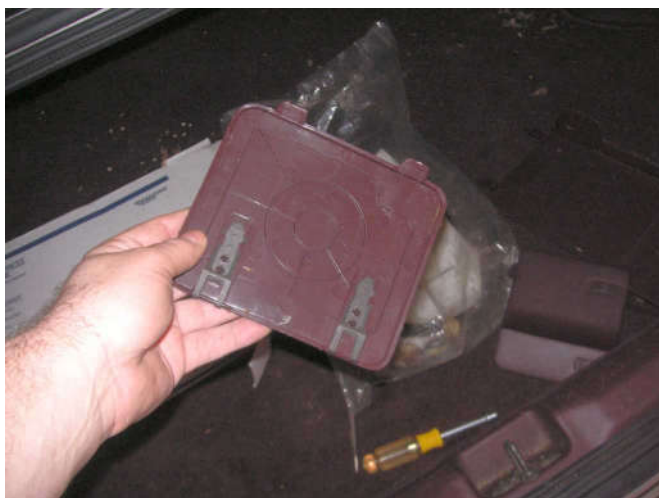
The covers over the lamp can be replaced, the little sliders are pretty straight-forward.
