## Why Ford Escort cam belts break

**Ford Escorts introduced in 1980 had a severe problem with camshaft belts breaking. This would grenade the engine.**

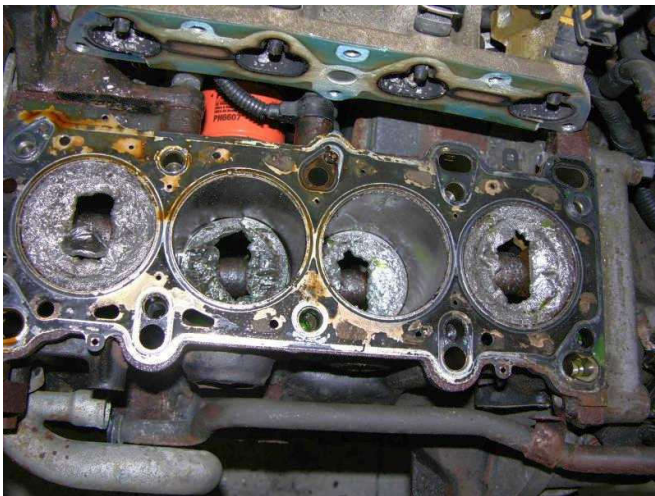
Figure 2; After his timing belt broke, Mike Robins (tinman19672009) can confirm his 2002 Kia Rio has an interfering engine.

When the Escort engine was mounted in a real car with rubber motor mounts, the motion and vibration of the engine in the car exacerbated the standing waves in the cam belt, and the belts started to break. The early Escort was also an interference engine, meaning that when the cam belt broke the valves would strike the pistons and grenade the whole engine (**figure 2**). In 1979 Ford was still held hostage by the McNamara finance idiot whiz kids.

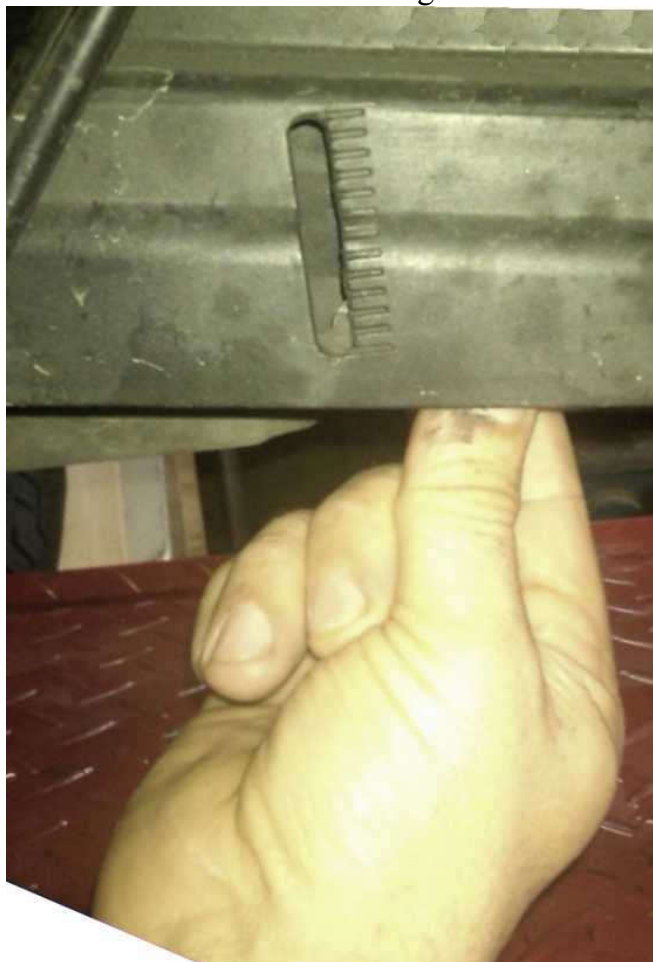
Figure 4; This Harley has marks on the drive belt guard to help you set the proper belt tension (courtesy hdfsforums.com).

They molded in distance marks to the belt guard and gave detailed procedure to adjust the belt (**figure 4**). I hear stories from my pals that the rear belts will last 120,000 miles. Still, my experience at Ford means I replace the rear belt when I replace the rear tire. I make sure the belt is running in the center of the sheaves and I leave it on the looser side when I adjust it.

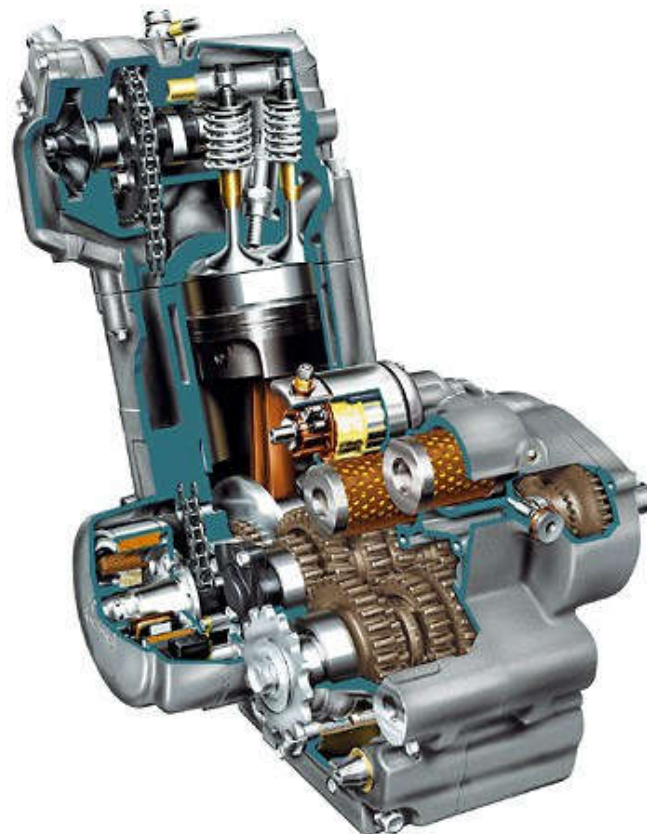
Figure 5; KTM motorcycle engineers drive the water pump via the camshaft to add damping to the "lumpy" camshaft loads (courtesy KTM).

One clever work-around is to drive the water pump with the camshaft (**figure 5**). This adds a nice smooth damped load to the lumpy cam load. I first heard of this on Kawasaki motorcycles, and found a KTM motorcycle engine that also uses this trick. Of course, if this puts the water pump above the radiator level, well then you have some new system engineering problems. Its another reason why designing systems is harder than designing components. There are so many trade-offs and interactions to deal with.

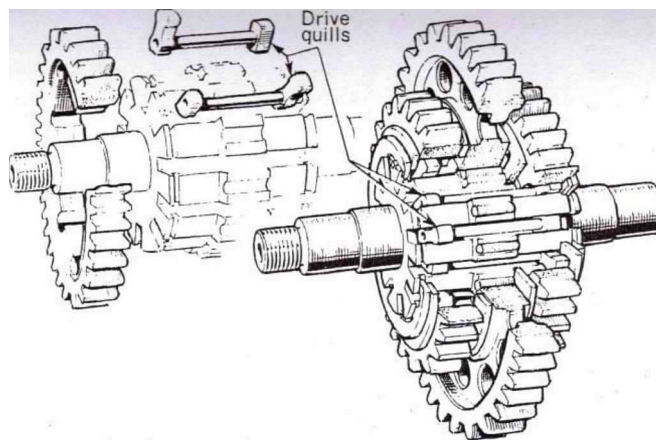
Figure 6; Keith Duckworth designed this cam drive in 1970. It has torsional compliance to prevent resonance-induced breakage at 10,000RPM (Courtesy Cosworth and Derek Taulbut).

drive to keep gear teeth from breaking at 10,000 RPM (**figure 6**).

A resonance made instantaneous load 12 times the theoretical. I don't think this is a good solution. It puts 1.5 degrees of compliance in the cam timing. This is way too sloppy for a modern engine, especially a pollution-controlled engine
