Engineering disaster: the Ford ignition

The 1980 Ford pickup ignition module was the worst reliability part in Ford history. Plus, it stranded you when it failed.

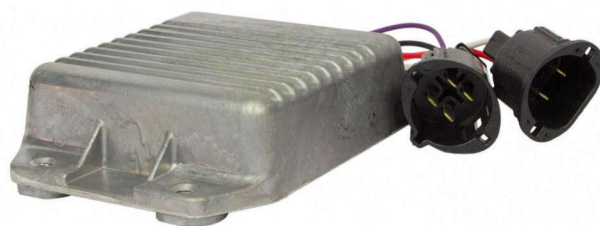
The 1980 Ford F-series pickup truck was a complete redesign. Part of the design effort was a new ignition module. This was not a management desire. Emission standards were changing, and a new module was needed. The huge problem with this module is that it mounted under the hood inside the engine compartment. We in the truck electrical group would have preferred it under the seat or behind the glove box, as was done on other cars. The problem inside the engine compartment is heat. The Arrhenius equation dictates that the hotter an electronic device is, the shorter its lifespan. Indeed, semiconductor manufacturers estimate a part's lifetime based on high-temperature tests that shortens the life.

So even before production, we were worried about the part's reliability. Little did we know that this part would become the worst reliability part in Ford history. I recall the failure rate to be around 12 R per hundred, that is, 12% failures in the warranty period. Since that cost Ford warranty money, this was a major problem. Worse yet, the failure would just kill the car, and Ford classed that as the worst possible failure mode.

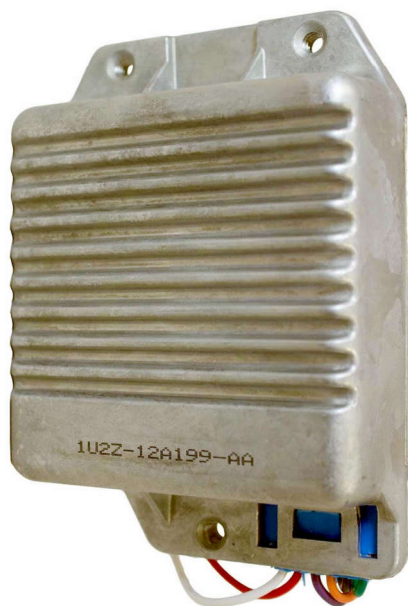
This is a genuine Motorcraft Ford service part. You can see the part number starts 1U2Z. A handy Ford part number decoder shows 1= 2001 release year, U2= Motorcraft Brand, and Z= Ford Customer Service Division Product Analysis / Ford Service Parts. This is a part number cut after 1999. When I worked on the truck, the part number started E0TB, E0= 1980, T= Truck, and B meant Body and Electrical Products Engineering (BEPE) release authority.

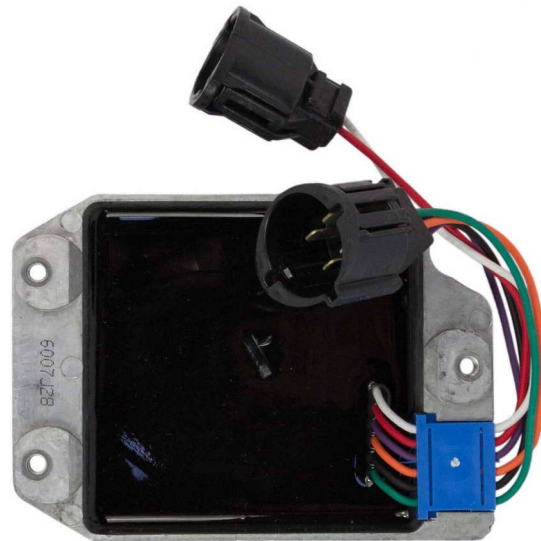
This is where the problem started. The circuit board was potted in the module with an epoxy filler. This caused the circuit board to crack when the module experienced temperature cycling under the hood. It was an insidious failure mode. Drivers would coast to the side of the road, open the hood, and poke around. This let the module cool, and broken circuit board traces would re-connect. Then the driver, clueless about what was going on, would get back in the car and it would start. Years later I met a tech that got stranded. He knew it was the module, so he unscrewed it and put a "drunk bump" he found nearby under the module. He screwed it down and it worked for five years.

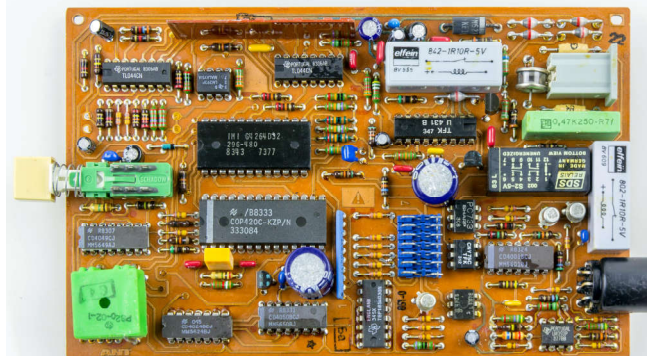
This is an example of a paper-phenolic circuit board. It is made from layers of paper glued together with thermoset phenolic plastic. You can often see them inside appliances and older cheap consumer electronics.

When the module heated up, from engine temperature and its own internal heating, the paper phenolic circuit board cracked. That killed the car.

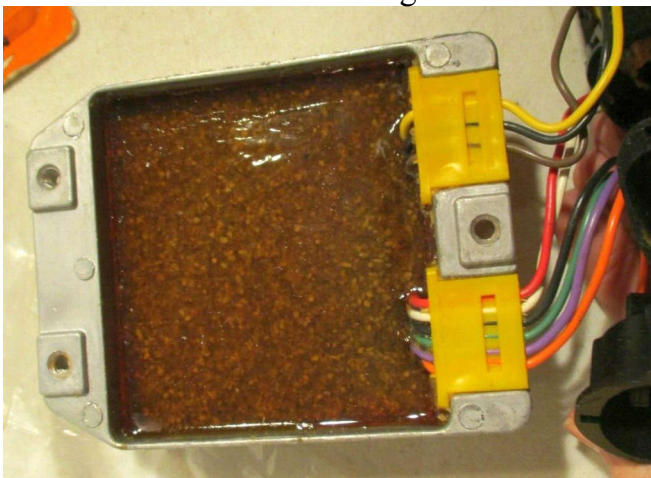
This is an aftermarket module, but you can almost see the sand underneath the potting.

Management looked at me like I was insane, FR-4 boards would be almost a dollar penalty, times six-million vehicles a year. Instead, the fix was to pour nice cheap sand into the housing, lay the board on top, then pot it in. Since sand is cheaper than potting, I think they could book it as a costs saving.

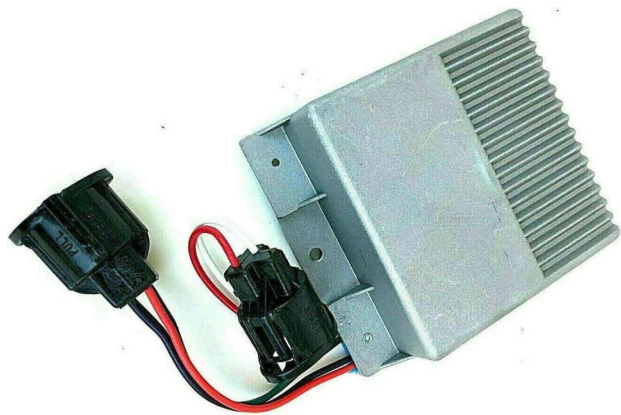
This is another aftermarket ignition module. They put fins where the high-current transistors are, and left the module smooth elsewhere. Pretty smart. When under the hood, the fins transfers heat out, but the cooler part of the module is smooth, minimizing heat transfer in.

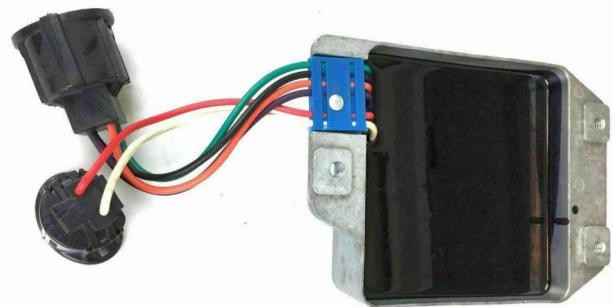
The underside of the aftermarket module shows the black potting compound.

Decades later I worked at Teledyne on high-voltage power supplies for aircraft radar tubes. They vacuum-potted a lot of electronic assemblies. It was there I learned that a hard potting compound transfers heat better. Yet it will also rip components apart when they temperature cycle. One tech told me he could fail anything with a few -55°C to 125°C temperature shock cycles. A flexible rubbery potting compound will keep things from breaking, but it is much worse at transferring the heat out.

So it is a delicate balance, designing the component heat characteristics, and selecting a potting compound and housing that will keep temperatures down but not be so stiff it will also break things inside the potting.
