Why Fords jump out of park

Ford vehicles in the 1970s and 80s would routinely jump, pop, or hop out of park. If the engine was running, it could kill you.

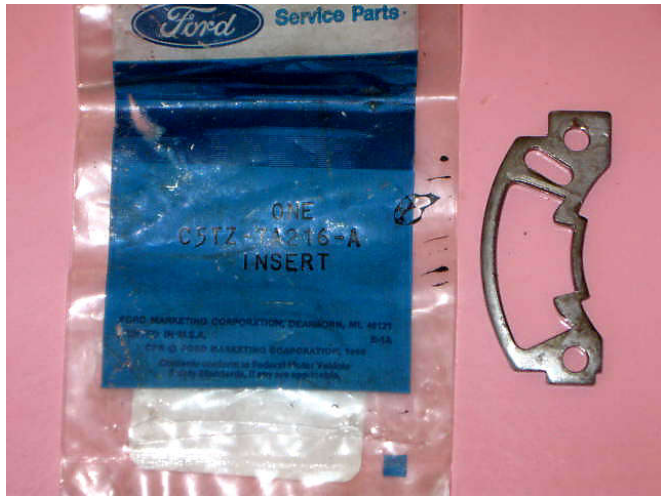
Here is a Ford OEM (original equipment manufacturer) version of the indent plate. They are getting hard to find OEM, but I suspect the aftermarket has come to the rescue. If you park on a hill, and feel the car roll forward or back, it can jam up the shift lever a bit. You really have to tug the lever to get it to move back so you can get it out of park. This pressure creates wear and that is what eats up these plates.

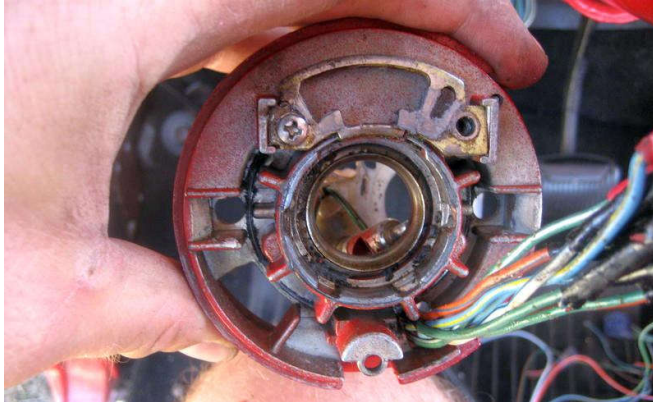
One wear-out failure was caused by this little plate in the steering column. It is why you have to pull the lever back to shift out of park. If the web between the two cutouts broke, the truck or car would jump out of park.

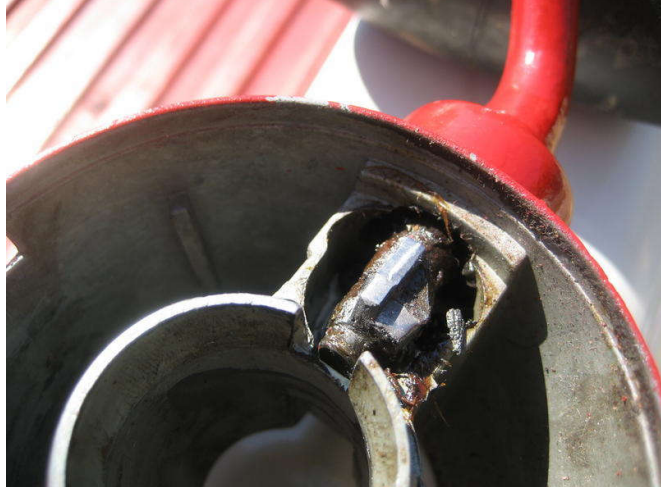
A related wear-out mechanism is the end of the column shift lever that drops into the slots on that plate. The protruding boss on the column can wear just like the plate. Replacing the plate is easy, but it is getting hard to find column levers in good shape.

Some folks are taking a file to the boss on the lever, so it fits more securely, but that is a dangerous patch, at best.

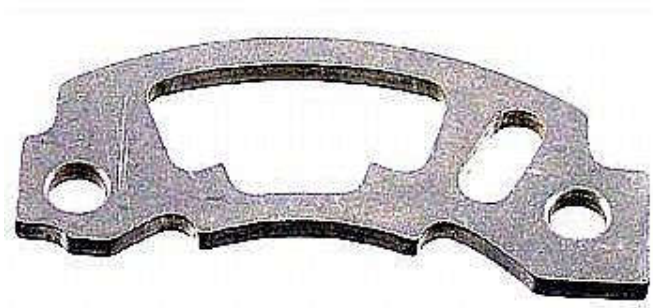
A new aftermarket indent plate. A rumor in 1980 was there was a car plate and a truck plate, color coded. They were late shipping, so we told them to skip the paint. I think it was the Louisville plant that built both cars and trucks, and the plates were in the wrong column. This only affected a few hundred trucks, and it might just be an engineering urban legend.

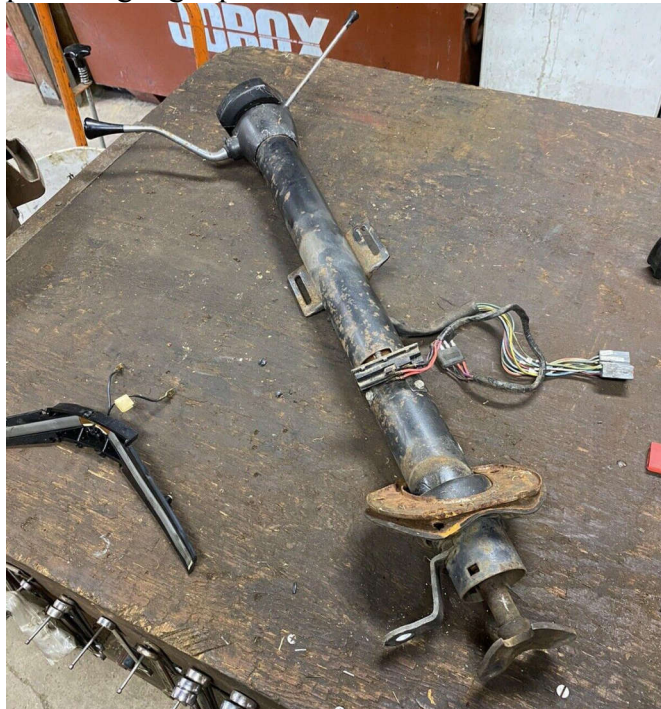
Here is a truck steering column. You can see how a bad plate or lever will make the lever at the bottom rotate out of park. I wondered if a cable might not have been better. Links are way more reliable, but you can see how we had to have a lot of linkage to accommodate the movement of the transmission and the cab body as you went over rough roads. The clutch often has a similar intermediate mechanism, to decouple the movement of the cab and engine from the operation of the clutch itself. All this adds up to a lot of things that can go wrong.

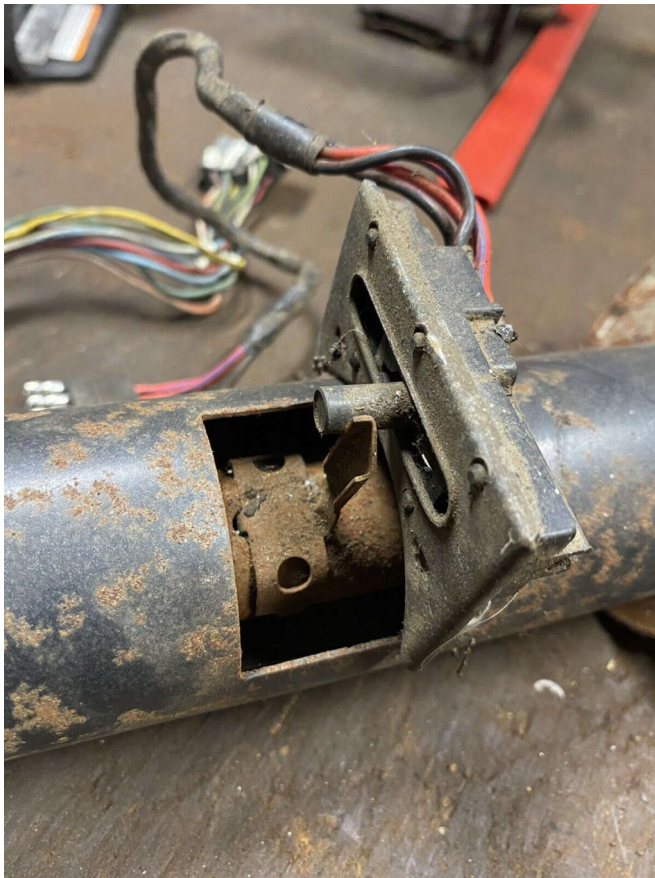
This is the reverse switch on the column.
