CMM-machine

A coordinate measuring machine to reverse- engineer Sportster engines.

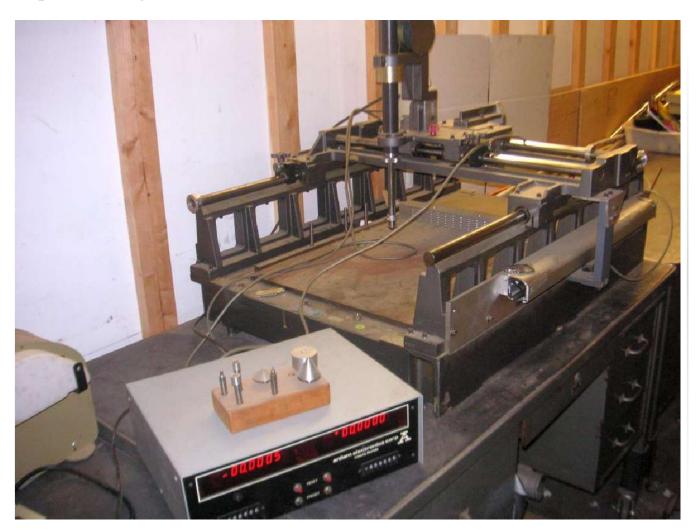
I bought this CMM machine from an ad in the San Jose Mercury News. I wanted it measure Harley Sportster case. This let me redesign the cases for a big project I have worked on for 20 years. Its somewhat home-made. It only measures X and Y, there is no Z measurement. This was not a problem since most of the measurements I needed were center-to-center dimensions between shafts and such.

The CMM had an Anilam readout.

The Z-axis drops down so a cone can center on whatever hole I needed to measure.

There were two linear optical scales. The unit was not as accurate as an air-bearing CMM, but it did the job I needed it to.

The back view shows the X-axis linear optical scale.

The unit had a very heavy cast-iron base and was quite stable. It moved smoothly and was quite repeatable.
